FROM: California Fatality Assessment and Control Evaluation (CA/FACE) Program

SUBJECT: A Construction Foreman Dies When the Construction Equipment He was Operating Tipped Over on Him

SUMMARY
California FACE Report #06CA003

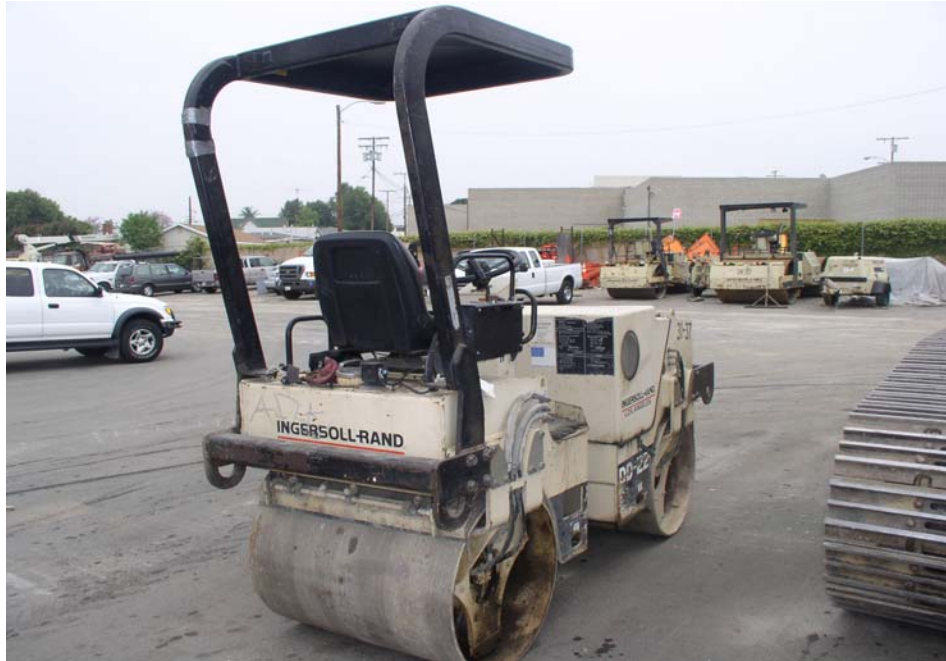
Exhibit 2. A picture of the rear of the compact roller involved in the incident.

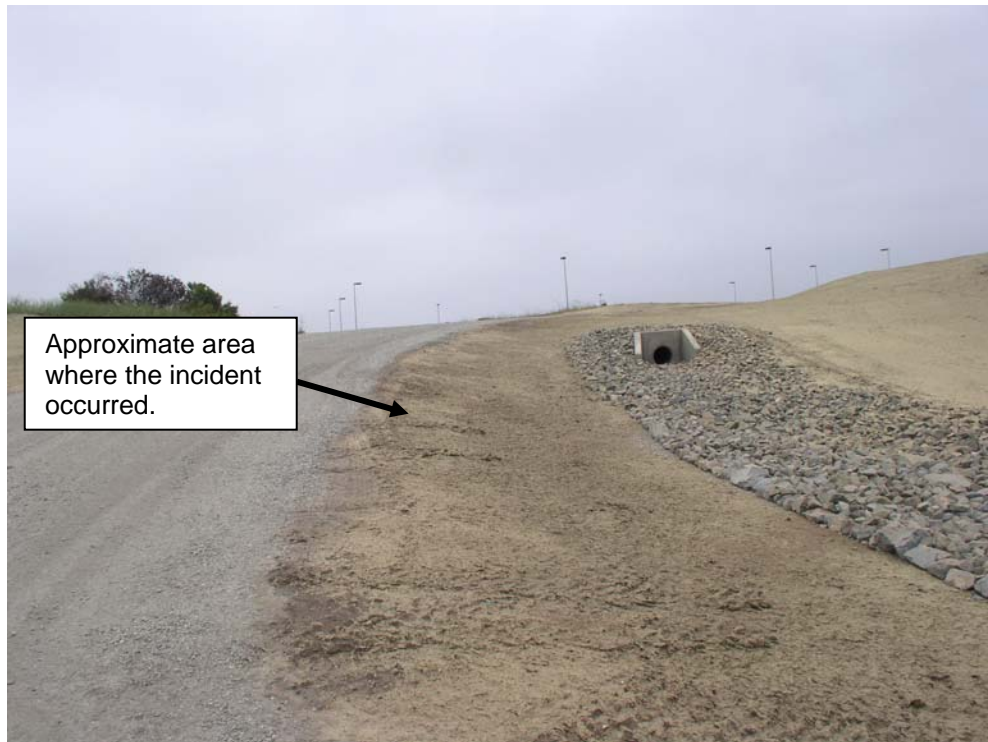
Exhibit 3. A picture of the roadway where the incident took place looking east.

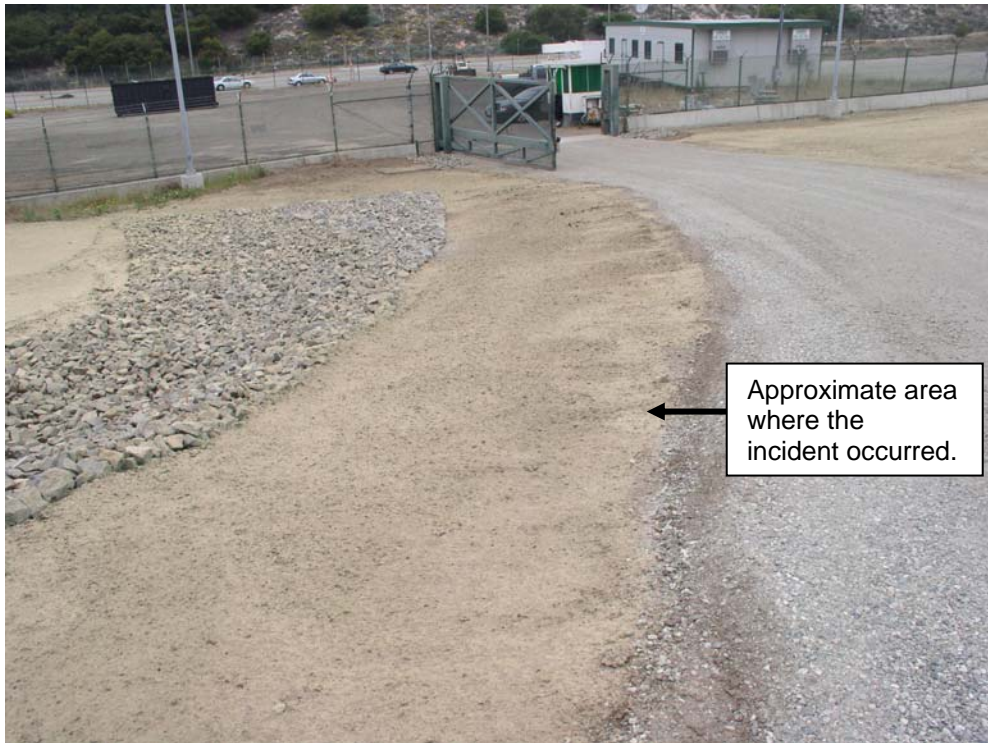
Exhibit 4. A picture of the roadway where the incident took place looking west.
